**REPAIR, EVALUATION, MAINTENANCE, AND
REHABILITATION RESEARCH PROGRAM**

TECHNICAL REPORT REMR-CO-3

**CASE HISTORIES OF CORPS BREAKWATER
AND JETTY STRUCTURES**

Report 1
SOUTH PACIFIC DIVISION

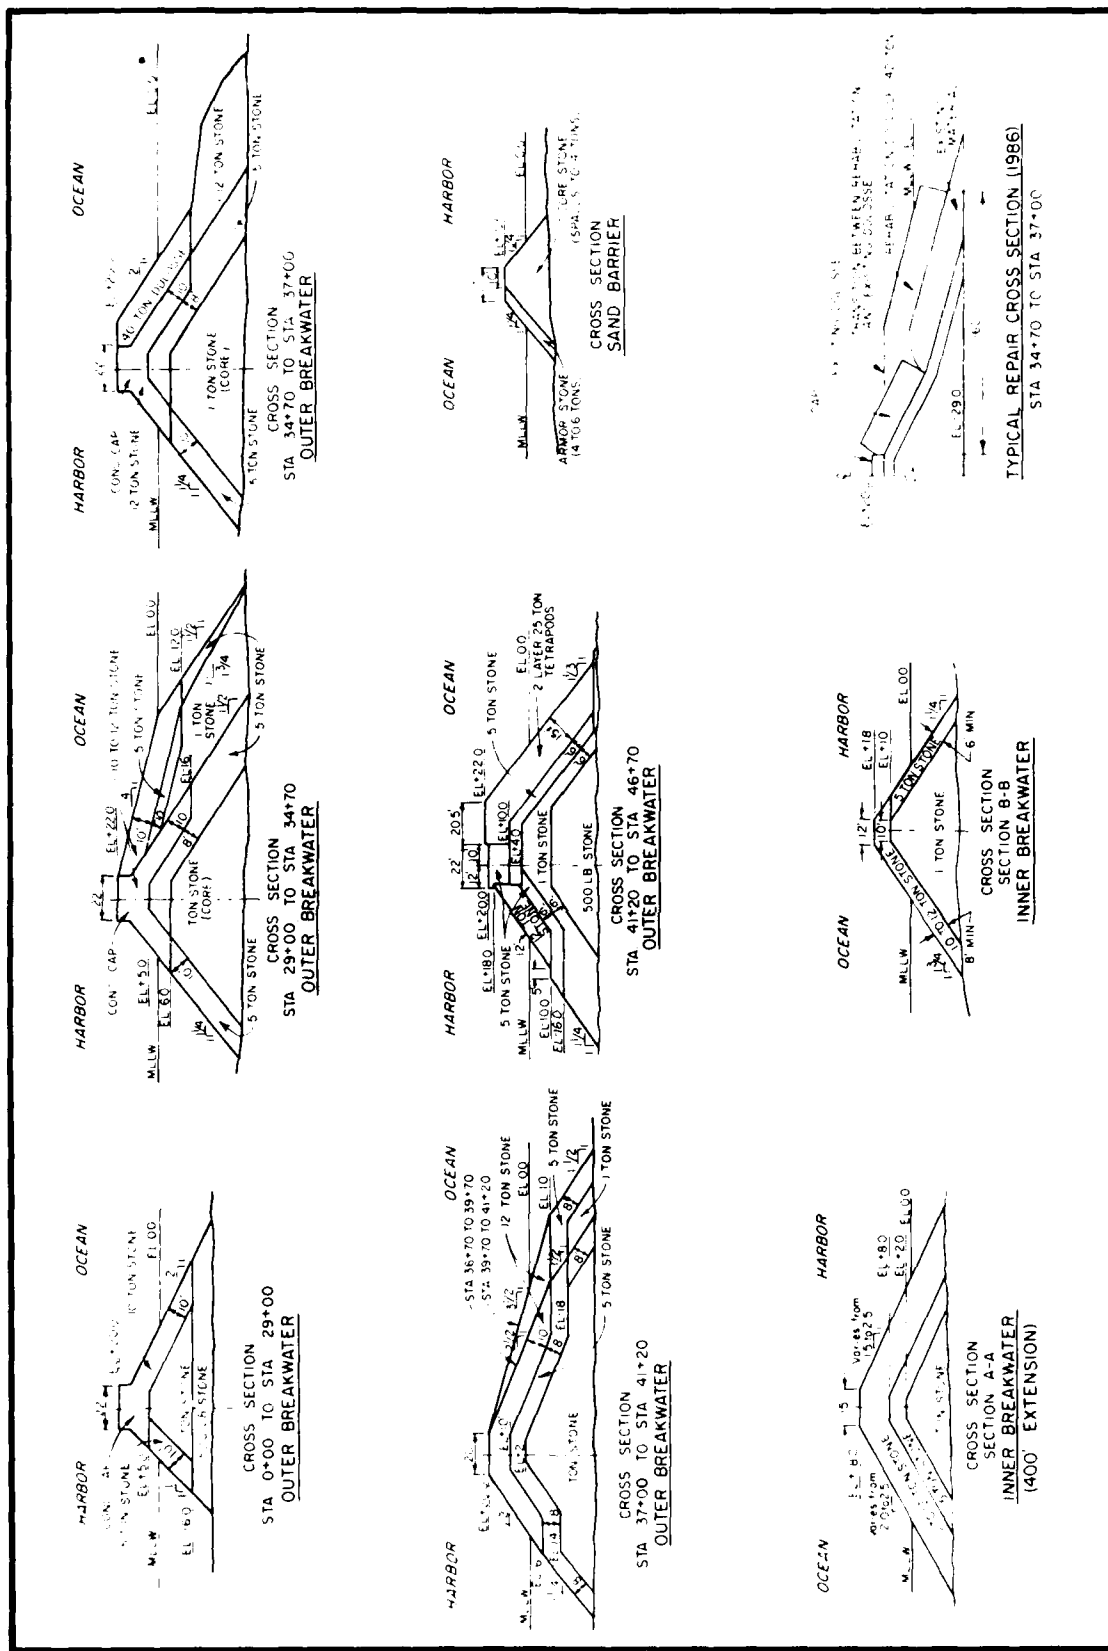
Figure 4. Typical structure cross sections, Crescent City Harbor, California

Date(s)	Construction and Rehabilitation History
1920- 1926	The initial work at the project (Figure 3) provided for a 3,000-ft-long rubble-mound breakwater, 6 to 11 ft above mean lower low water (mllw) with a 20-ft crest width. The first 2,245-ft length of breakwater was completed in 1926. Ten-ton armor stones were used for slope protection (Figure 4).
1928- 1930	A 14-ft-wide concrete cap was added to the original 2,245 ft of structure raising the crest elevation to 14 ft mllw.
1931	An additional 755 ft of breakwater construction was completed resulting in a 3,000-ft-long structure.
1939	Construction of a rubble-mound sand barrier connecting Whaler Island to the shore (Figure 3) was completed to prevent shoaling. The barrier structure was 17 ft wide at its crest with an elevation* of +10 ft mllw (Figure 4). An armor layer of 4- to 6-ton stones protected the ocean side of the sand barrier.
1946	Construction of a 1,200-ft-long inner breakwater was completed to provide protection to a small-craft basin. The inner breakwater extended from Whaler Island northwest (Figure 3). The crest el of the structure was +18 ft mllw (Figure 4) and 10- to 12-ton armor stones were utilized during construction.

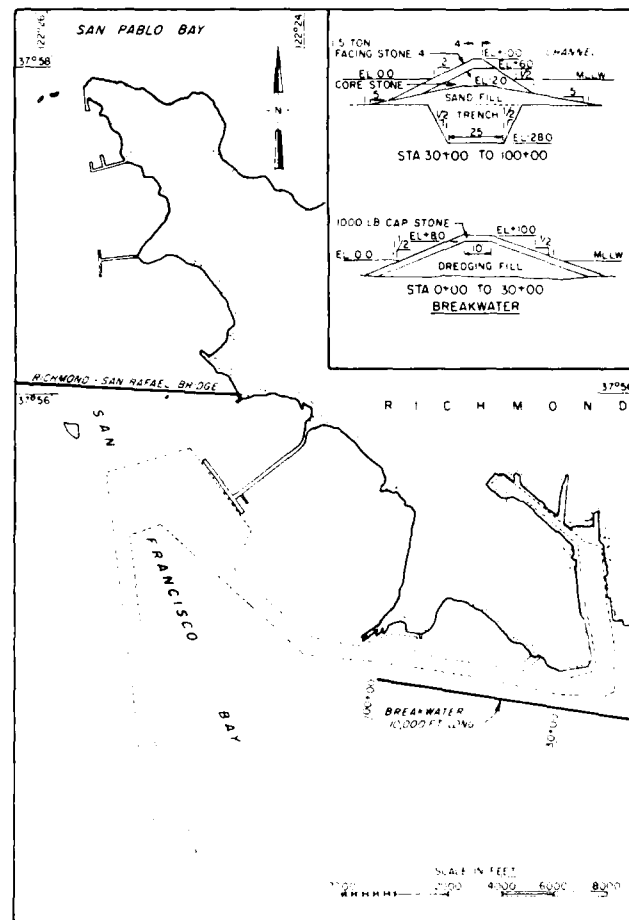
Figure 10. Richmond Harbor, San Francisco Bay, California

Date(s)	Construction and Rehabilitation History
1923-1931	Construction of a 10,000-ft-long breakwater (also referred to as a training wall) was completed (Figure 10) during this time frame. The seaward 3,000-ft-long portion of the breakwater had a 10-ft crest width and a 10-ft mllw crest el. Side slopes were 1V:1.5H. The remaining portion of the breakwater entailed a 10-ft mllw crest el and a 4-ft crest width. Side slopes were 1V:2H on the bay side and 1V:1.5H on the channel side.
1967	Rehabilitation of the breakwater was performed. The extent of the work is not known, however.
1985	The breakwater again underwent repairs and is considered to be in good condition.

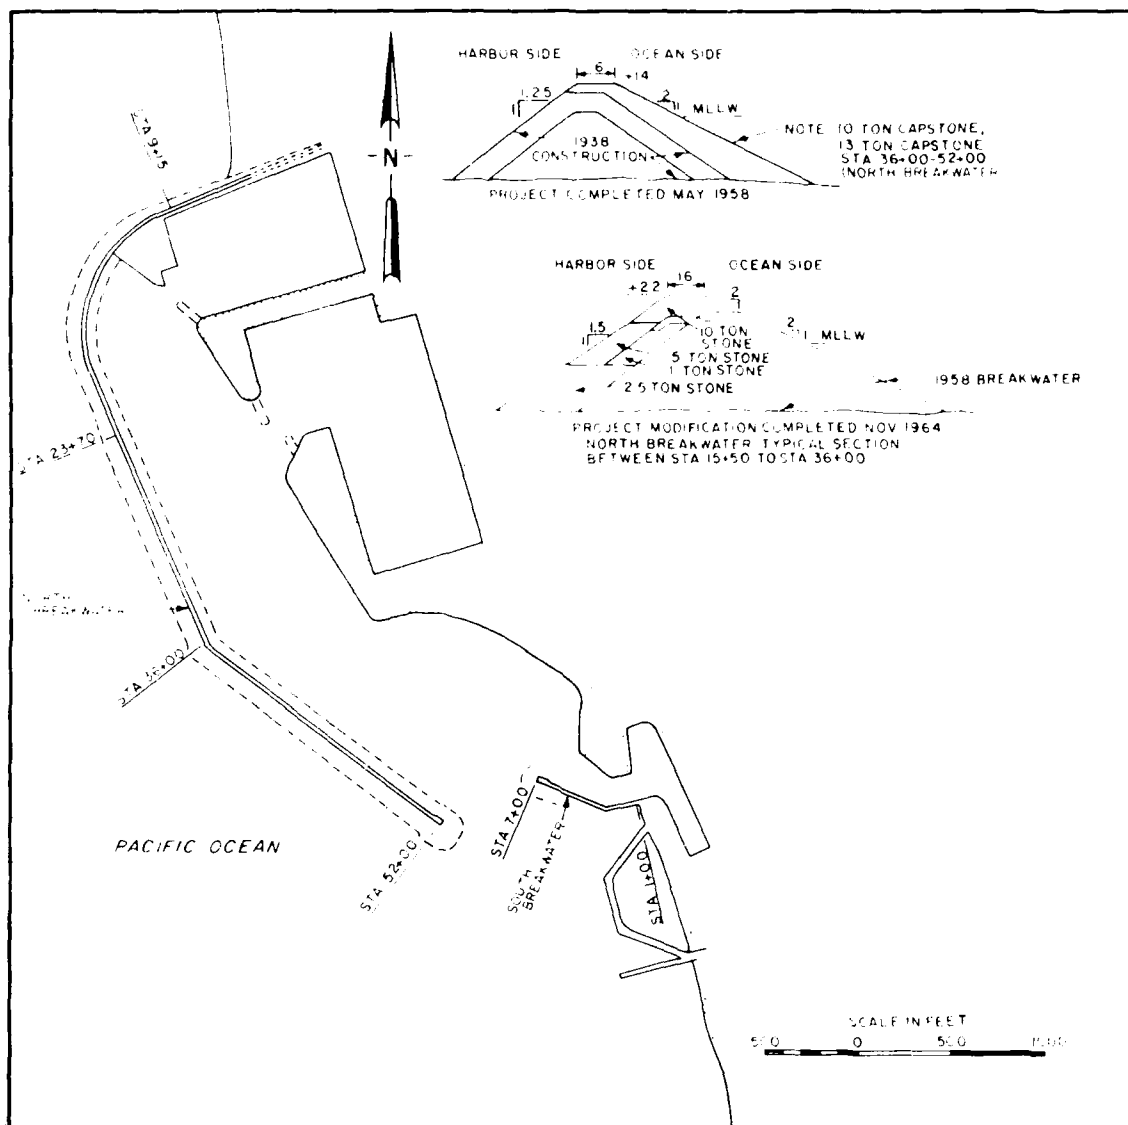
Figure 28. Redondo Beach King Harbor, California

<u>Date(s)</u>	<u>Construction and Rehabilitation History</u>
1938	Construction of a 4,285-ft-long permeable, rubble-mound breakwater (Figure 28) was completed.
1950	The breakwater became a Federal project, and improvements were authorized.
1958	Ten-ton capstones were placed on the ocean side of the breakwater on a 1V:2H slope, and the crest was raised to +14 ft mllw and increased to 16 ft in width. Thirteen-ton capstones were used on the breakwater between sta 36+00 and 52+00. A 600-ft-long south breakwater with a crest el of +14 ft was constructed. The structure has a 16-ft crest width, and side slopes were 1V:2H on the sea side and 1V:1.5H on the harbor side.
1960	Minor repairs to the north breakwater (from a storm in 1959) were completed.
1963	Storms demonstrated the inadequacy of the north breakwater for protecting small craft within the Harbor. While doing only minor damage to the breakwater, damage to small boats and Harbor facilities amounted to \$431,000.

1964	The north breakwater (between sta 15+50 and 36+00) was modified. The structure crest el was raised to +22 ft mllw at this location. Stones, ranging from 2.5 to 10 tons, were placed on the harbor side of the breakwater on a slope of 1V:1.5H (Figure 28).
1978- 1980	Storms of 1978 and 1980 resulted in damage to the north breakwater in nine areas with major voids occurring at sta 16+00 and 22+00.
1982	As a result of the damages in 1978 and 1980, the north breakwater was repaired at a cost of \$304,000.
1983	Storms resulted in significant damage at several locations along the north breakwater. The most significant was a breach 70 ft long, just south of the curved portion. Repair work was completed, and approximately 5,300 tons of new capstone and 1,700 tons of corestone were utilized. At seven additional locations, about 4,000 tons of capstone were replaced. The repair work cost approximately \$400,000.

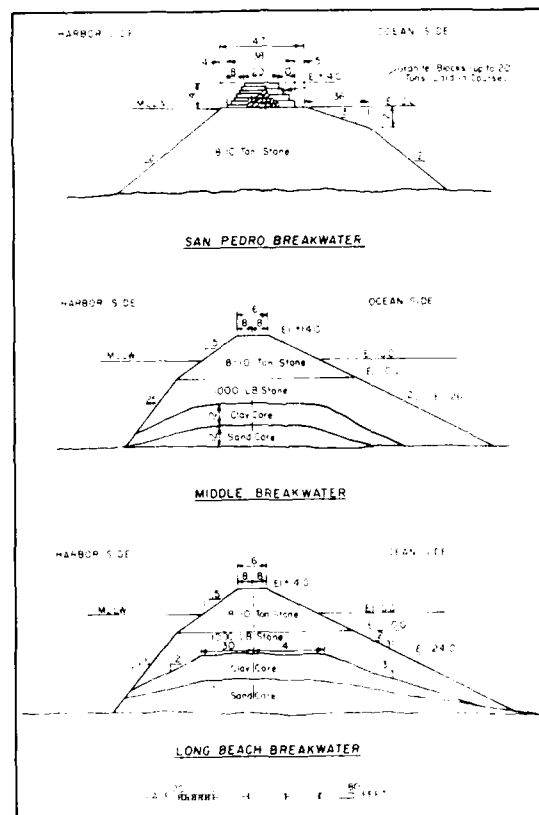
Figure 30. Breakwater cross sections, Los Angeles and Long Beach Harbors, California

Date(s)	Construction and Rehabilitation History
1898- 1910	Construction of the 11,152-ft-long San Pedro Breakwater occurred at the site (Figure 29). The harbor side of the structure was built with 1V:1.2H side slopes, while the ocean side consisted of 1V:1.2H slopes from the bottom up to an el of -12 ft mllw. At this point the slope changed to 1V:3H to an el of 0.0 ft mllw. The rubble-mound portion of the structure (Figure 30) was 47 ft wide at el 0.0 ft mllw. Granite blocks (up to 20 ton) were laid in courses to an el of +14 ft with a crest width of 20 ft. The rubble-mound portion of the structure was constructed with 8- to 10-ton stone and was permeable. Other structures, which are now incorporated into the inner harbor works, were constructed as early as 1871.
1930- 1938	Construction of the 18,500-ft-long rubble-mound middle breakwater (Figure 29) was in progress. The breakwater had a 16-ft crest width at el +14 ft mllw. Side slopes on the ocean side were 1V:2H and on the harbor side ranged from 1V:1.25H to 1V:1.5H (Figure 30). An impermeable core was installed from the bottom (approximately -50 ft mllw) to el -26 ft mllw.

1942- 1960	Construction of the 13,350-ft-long rubble-mound Long Beach Breakwater (Figure 29) occurred during this period. With the exception of the breakwater core el (Figure 30) the cross section of this structure was similar to that of the middle breakwater.
1947	Repairs to the middle breakwater were accomplished for a cost of \$786,700.
1983	Winter storms resulted in extensive damage to the San Pedro Breakwater. The structure was breached in an area immediately seaward of the curved portion of the breakwater. Model tests were conducted after the damage (Carver 1984, Baumgartner, et al. 1986), and restoration of the San Pedro Breakwater was subsequently completed. Work consisted of the placement of approximately 25,000 tons of salvage stone and new angular stones ranging from 15 to 25 tons each. Where voids occurred on the crest after this stone placement, concrete was pumped into flexible temporary forms to complete the repair.

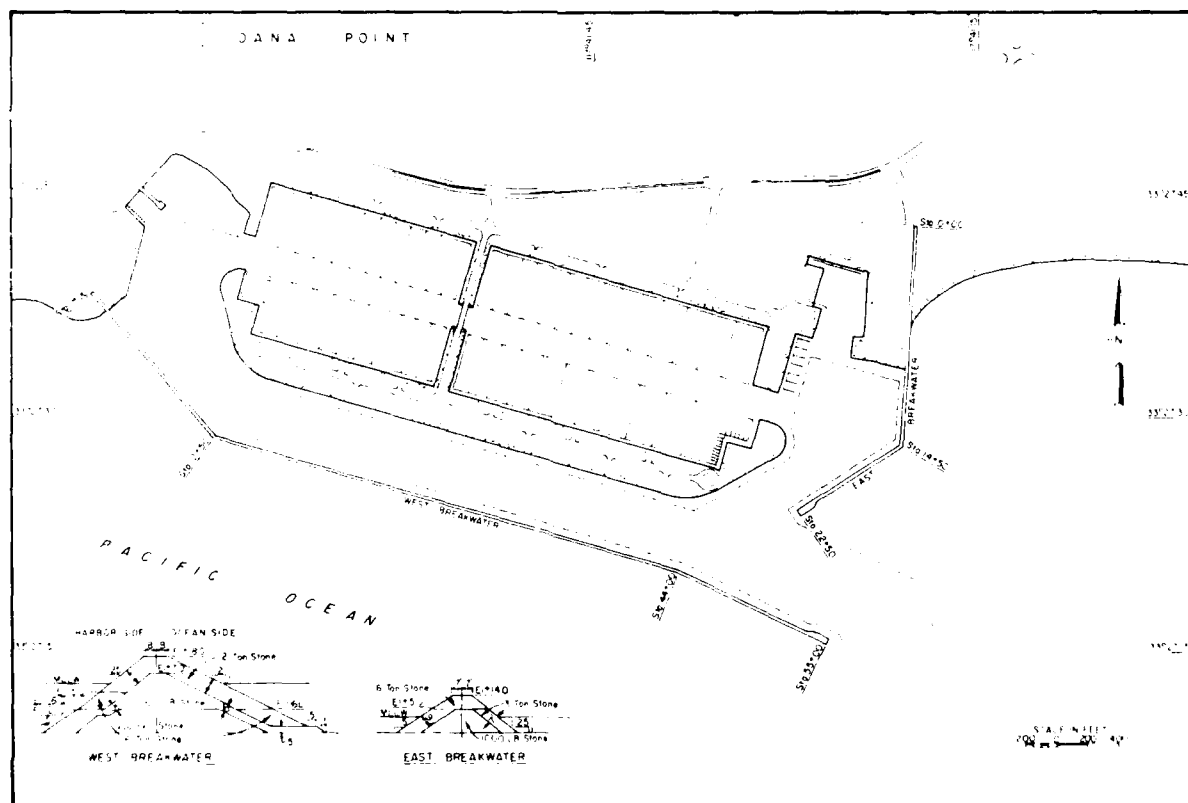
Figure 32. Dana Point Harbor, California

Date(s)	Construction and Rehabilitation History
1968	Construction of two rubble-mound breakwaters at the site (Figure 32) was completed. The west breakwater was 5,500 ft long with a 16-ft-wide crest at el of +18 ft mllw. The ocean side slope of the structure was 1V:2H, and the harbor side was 1V:1.25H. The east breakwater was 2,250 ft long with a 14-ft-wide crest width and a +14-ft el mllw. The ocean-side slope was 1V:1.5H, and the harbor-side slope was 1V:1.25H. Model tests were conducted for the project (Dai and Jackson 1966, Wilson 1966).
1983	Major storms resulted in approximately \$610,000 in damages to the breakwater.
1984	Restoration of the west breakwater in nine locations was completed. About 5,800 tons of capstone were used for this maintenance repair.
1986	The breakwaters are in satisfactory condition.

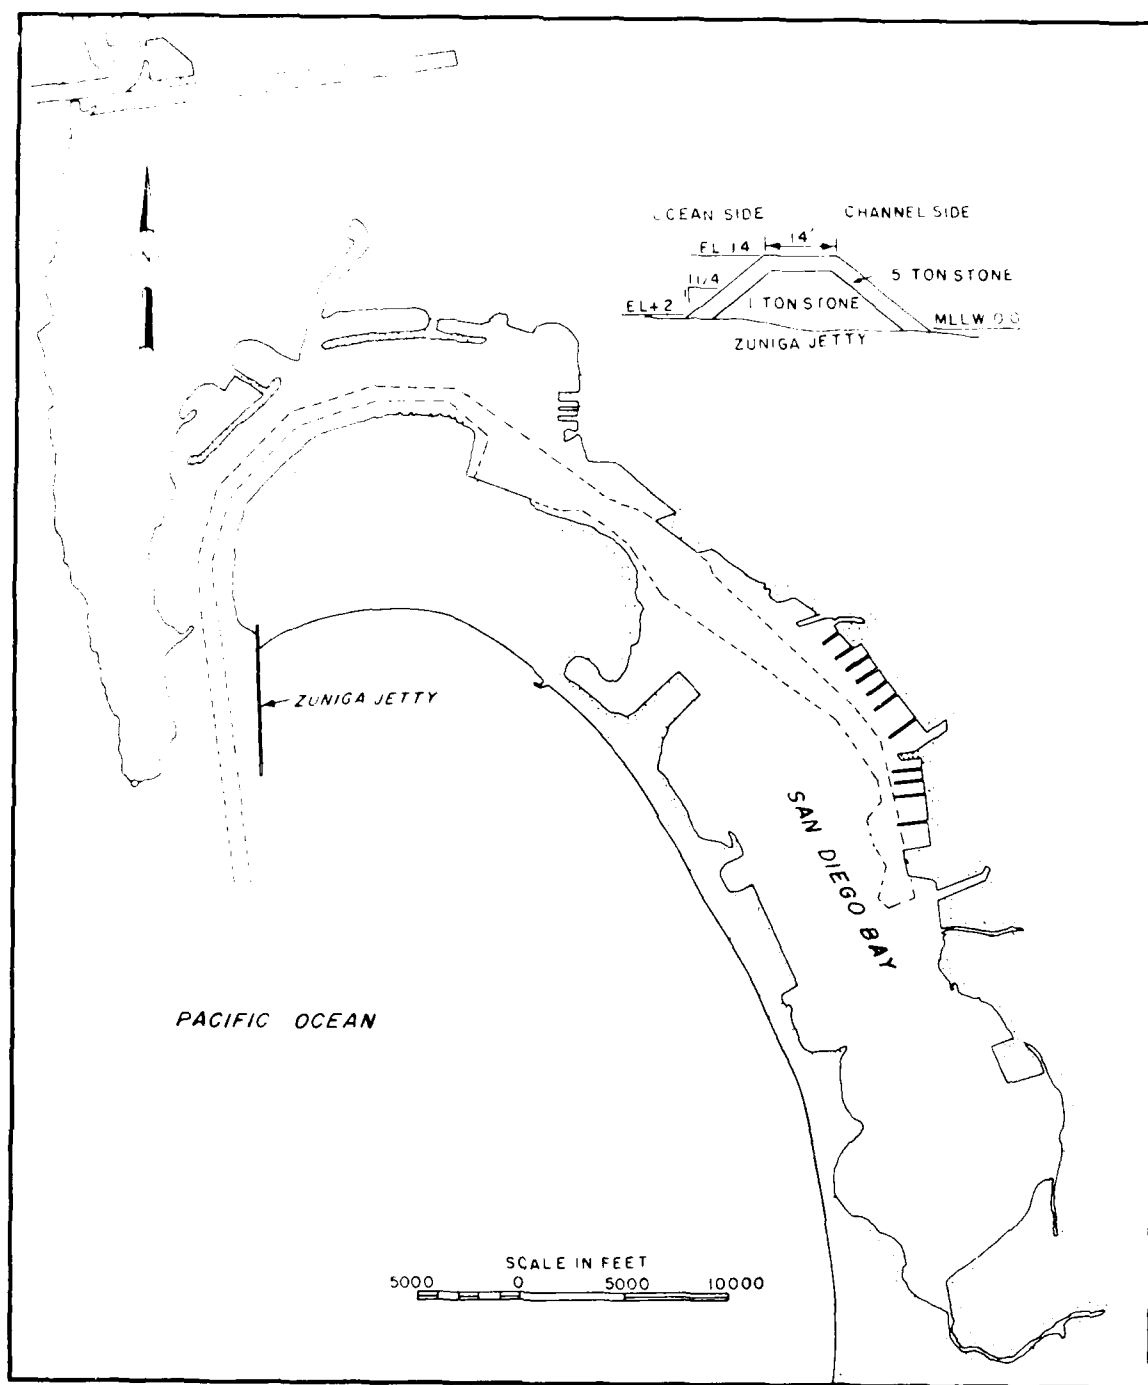
Figure 35. San Diego Harbor, California

Date(s)	Construction and Rehabilitation History
1894-1902	Construction of a 7,500-ft-long rubble-mound jetty (Zuniga Jetty) was completed (Figure 35) during this time frame. The design height of the jetty was +14 ft mllw with a 14-ft-wide crest. Side slopes were 1V:1.25H. It is indicated, however, that the jetty was not constructed to the full design height.
1942	Rehabilitation work was performed by the US Navy from the shoreward end to a point about 1,400 ft seaward.
1943-1969	Settlement and flattening of the slopes occurred, particularly in the outermost third of the jetty. As a result, parts of the jetty were awash or submerged at most tide stages, creating hazards to navigation.
1970	Maintenance repair of the jetty was accomplished for a cost of approximately \$127,000. This work consisted of the construction of platforms on the jetty for navigation lights which were installed by the US Coast Guard to alleviate hazards to navigation.

1984	Maintenance repair of the jetty was completed, the extent of which is unknown.
1986	Even though the jetty was not constructed to full design height, it functions satisfactorily as a training wall which concentrates tidal flows and keeps the entrance channel scoured to project depth.
